Home Watch [Full Inspection]

Test Client

94 Testing St
South Dennis, MA 02660
United States
(41.XXXXXXXXXX, -70.XXXXXXXXXX)

3/7/16, 13:33

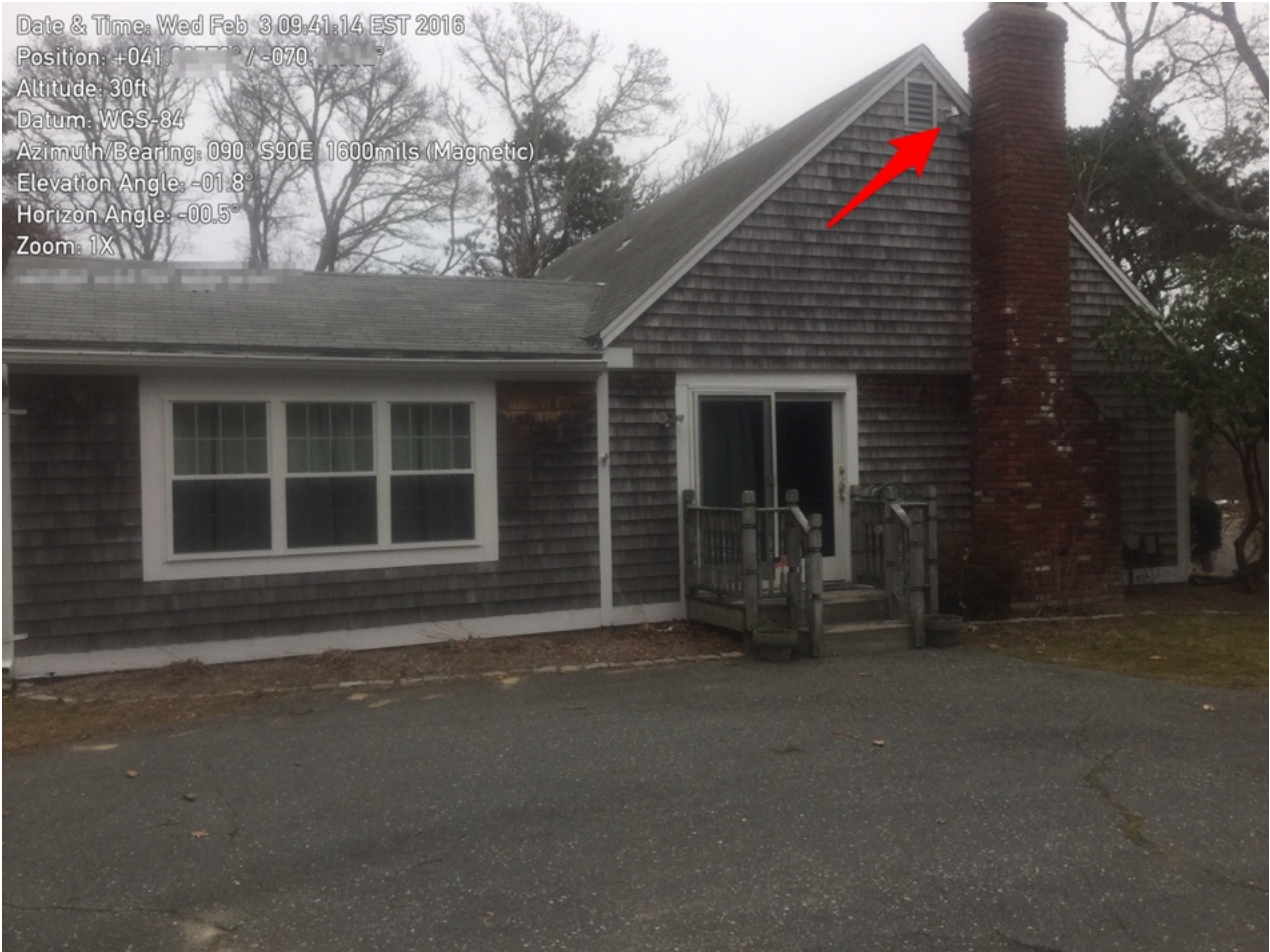
Appendix 1

Question	Response	Details
Property Grounds		Score (4/5) 80%
Are the driveway and property entrances clear?	Yes	
Yard and landscaping in good condition?	Yes	
Sheds and outbuildings in good condition?	Yes	
Does the property appear to be occupied at first glance? (if you didn't know better)	No	Shades drawn.
Does it appear that the property has NOT been visited since the last inspection? (there are no visible tire tracks, footprints or other signs of trespass)	Yes	
Property grounds notes	Yard has downed limbs from last storm.	
Main House Exterior		Score (4/4) 100%
Is the roof in good condition and free of ice dams or any other roofing issues?	Yes	
Is the siding of the structure in good condition?	Yes	
Do all the exterior security lights appear to be working properly? (If applicable)	N/A	
Are all the windows secure?	Yes	
Are all the doors secure?	Yes	
Main house exterior notes	Gutter guard came off from gutter. See attached pic.

Date & Time: Wed Feb 3 10:32:17 EST 2016
Position: +041° / -070.1°
Altitude: 73ft
Datum: WGS-84
Azimuth/Bearing: 311° N49W 5529mils (Magnetic)
Elevation Angle: +08.8°
Horizon Angle: +01.3°
Zoom: 1X
gutter guard came off from gutter
