# Security Patrol [Exterior Check]

**Joe Homeowner**

000074

123 Test St  
South Dennis, MA 02660  
United States  
(41.XXXXXX, -70.XXXXXX)

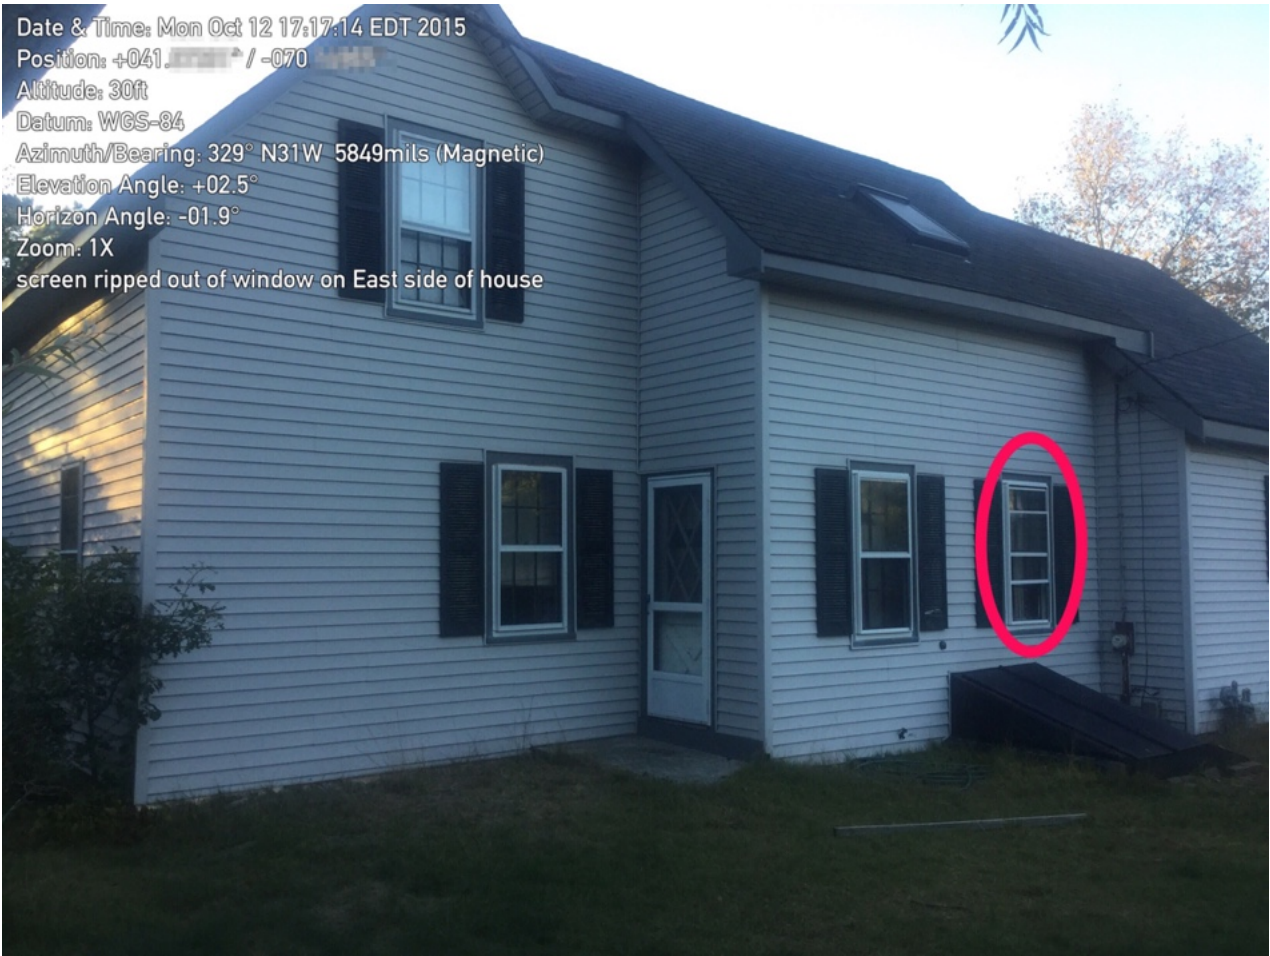
Appendix 1

Question	Response	Details
Are the doors of the buildings on the property secure?	Yes	
Are the windows of the buildings on the property secure?	Yes	
Are the buildings void of any signs of intrusion or security breach?	Yes	
Are the exteriors (roofing, siding) of the building(s) free of any storm or vandalism damage?	Yes	
Are the building(s) free of any environmental/maintenance issues like ice dams, clogged gutters, etc?	Yes	
Are all the exterior lights on the property working properly? (If applicable)	N/A	
<b>Incident Reporting</b>		Score (3/9) 33.33%
We're there any incidents or issues found during this patrol check that need further reporting?	Yes	Window screen on East side of house first floor damaged.
Please select and describe below in detail the issue(s) discovered during this patrol	Storm/Weather Damage, Vandalism, Other	
Patrol Incident Details	Window screen damaged. Appears to have been ripped out. Unclear what caused the damage. Window is locked and secure. Damage is limited to Window screen only.

Date & Time: Mon Oct 12 17:17:14 EDT 2015  
Position: +041. / -070  
Altitude: 30ft  
Datum: WGS-84  
Azimuth/Bearing: 329° N31W 5849mils (Magnetic)  
Elevation Angle: +02.5°  
Horizon Angle: -01.9°  
Zoom: 1X  
screen ripped out of window on East side of house

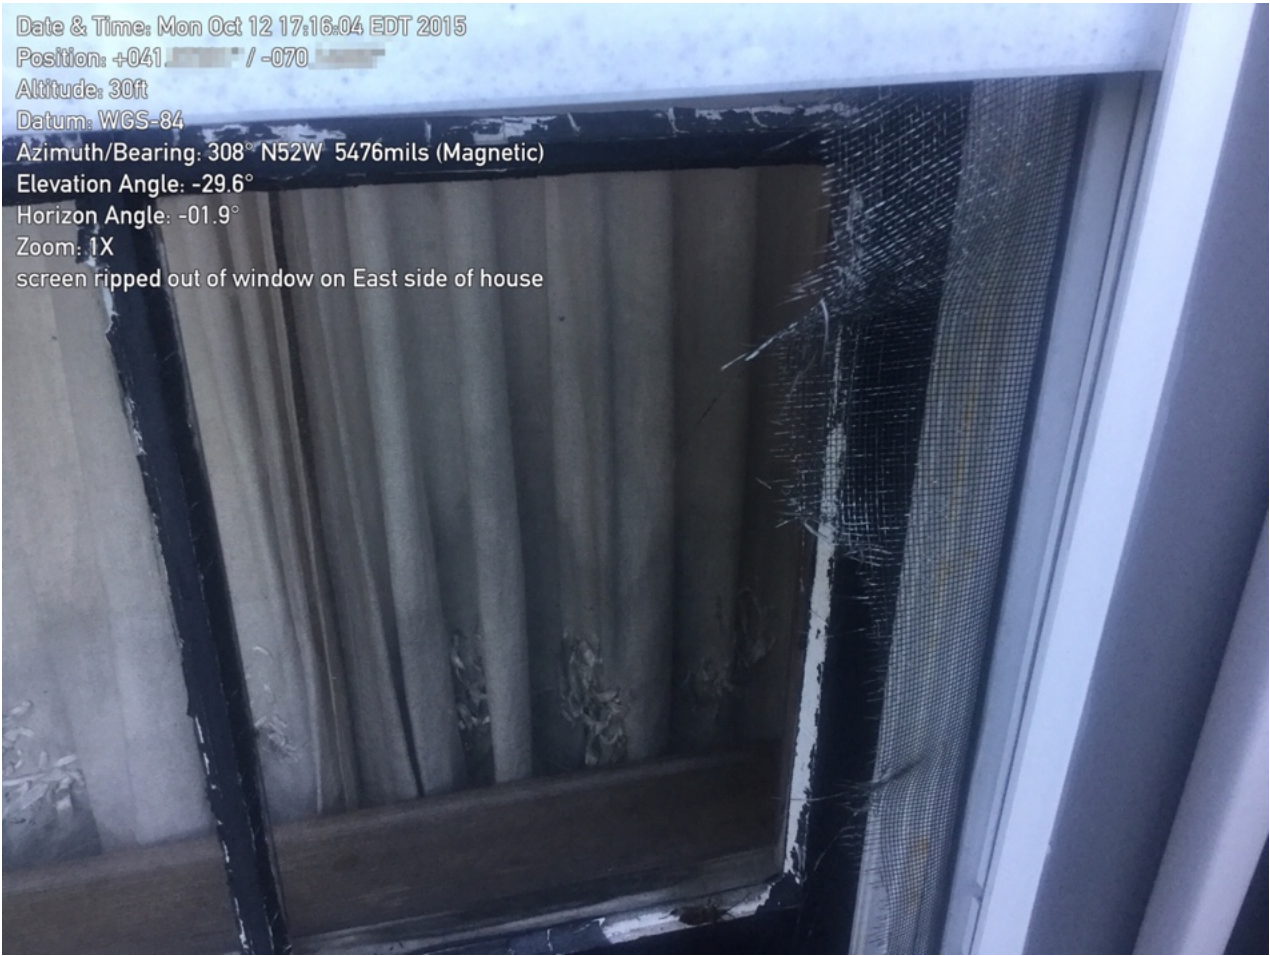
Appendix 2

Date & Time: Mon Oct 12 17:16:04 EDT 2015  
Position: +041. / -070.  
Altitude: 30ft  
Datum: WGS-84  
Azimuth/Bearing: 308° N52W 5476mils (Magnetic)  
Elevation Angle: -29.6°  
Horizon Angle: -01.9°  
Zoom: 1X  
screen ripped out of window on East side of house

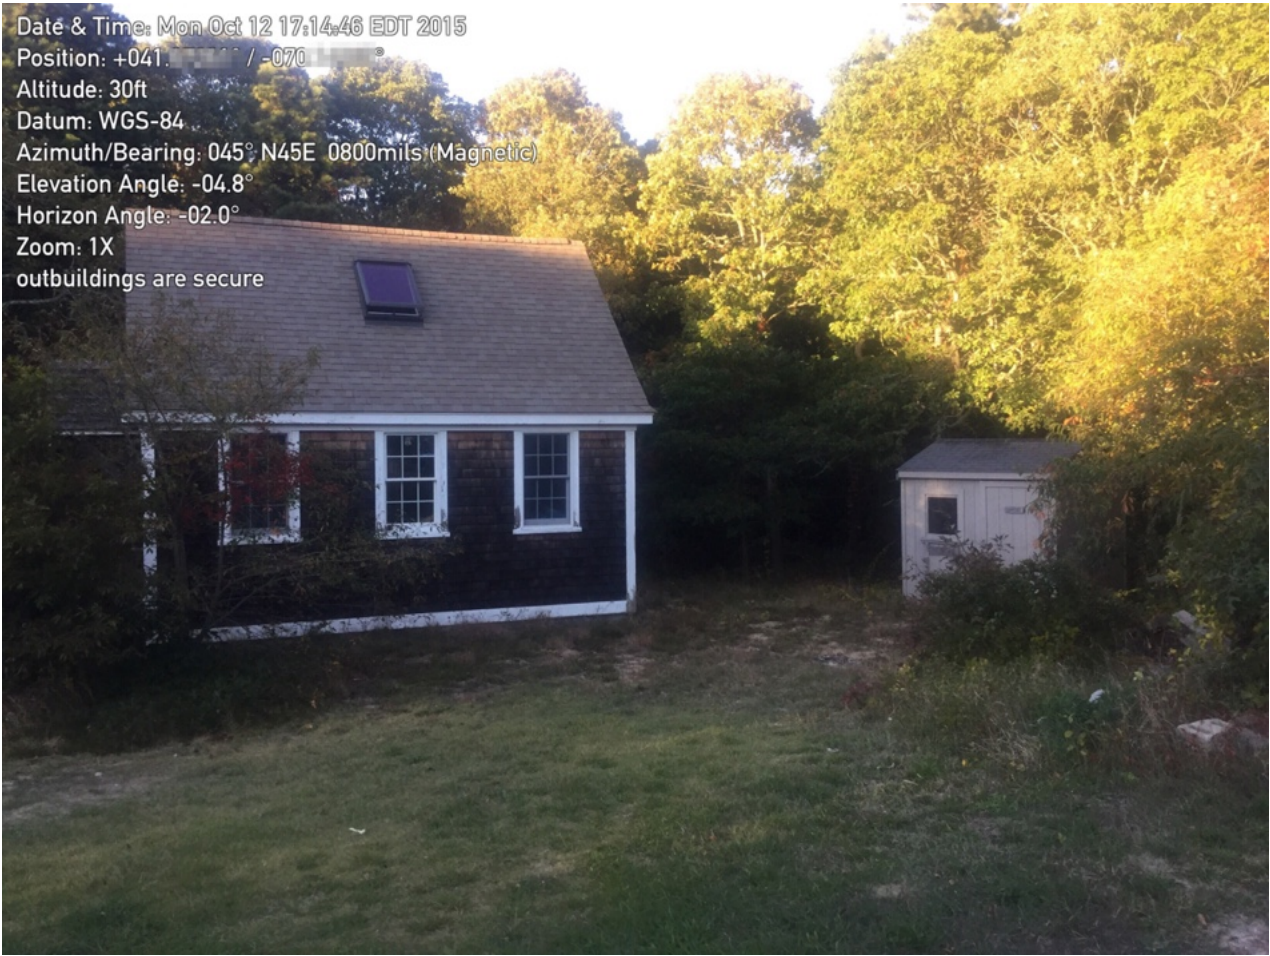
### Appendix 3

outbuildings are secure
